It Just

By AE2 Jason Rogers

Fell Apart

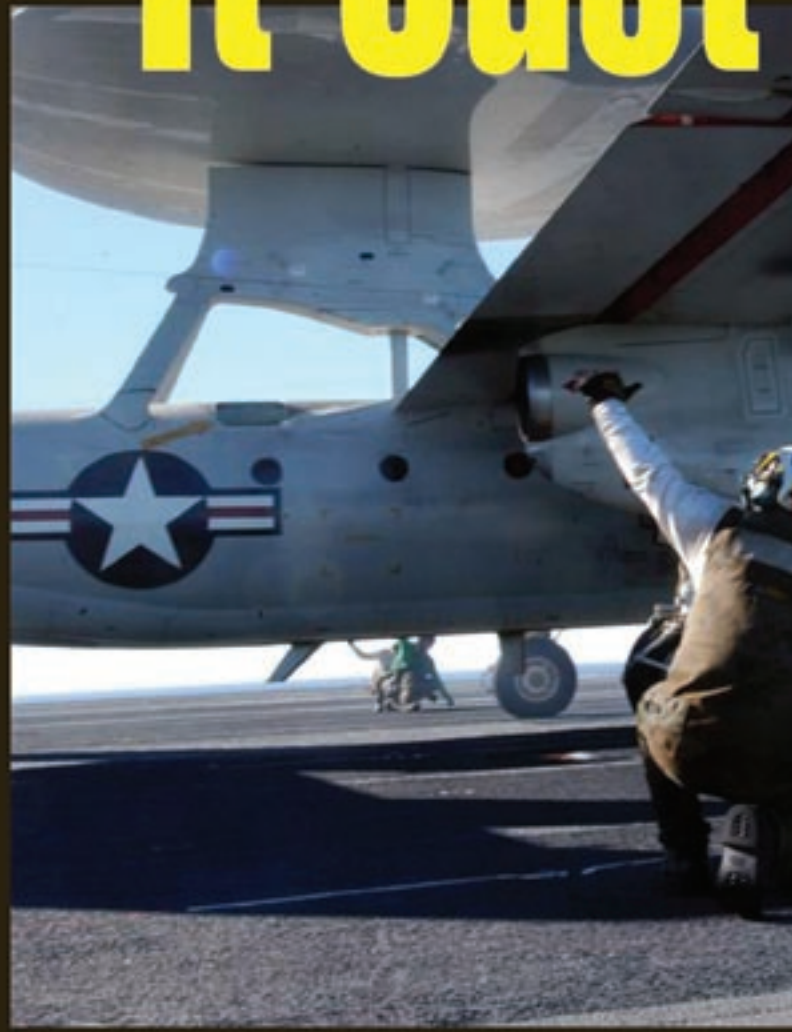
The small amplifier connects to the ADI.

for the night. I then headed down to my shop to do a tool inventory and to call it a night. The night-check supervisor grabbed me and told me a part was missing off the back of the ADI that had been given to supply. The item was a small power amplifier that is attached

The missing part is not easy to lose because it is held in place with two screws and a cannon plug. I

After the aircraft recovered early, QA found the missing part behind the co-pilot's instrument panel, just above the rudder-pedal adjustment handle. This location is just below the mounting point for the ADI, but it's behind a valance, explaining why the aircrew didn't notice it. I initially was shocked at this discovery, but, after putting together all the information after the fact, it made sense.

The aircrew had a problem with the ADI just after the catapult shot on the first sortie. We believe that shot caused the amplifier to fall off the back of the ADI. AIMD technicians explained that the ADI would not work without that part. Two screws and a cannon plug should not have fallen off. Therefore, the hardware and cannon plug probably had not been installed correctly two weeks earlier. Nevertheless, as the CDI for the job, I should have taken a few extra seconds to inspect all the parts removed and replaced. Had I done that, the missing part would have been noticed.

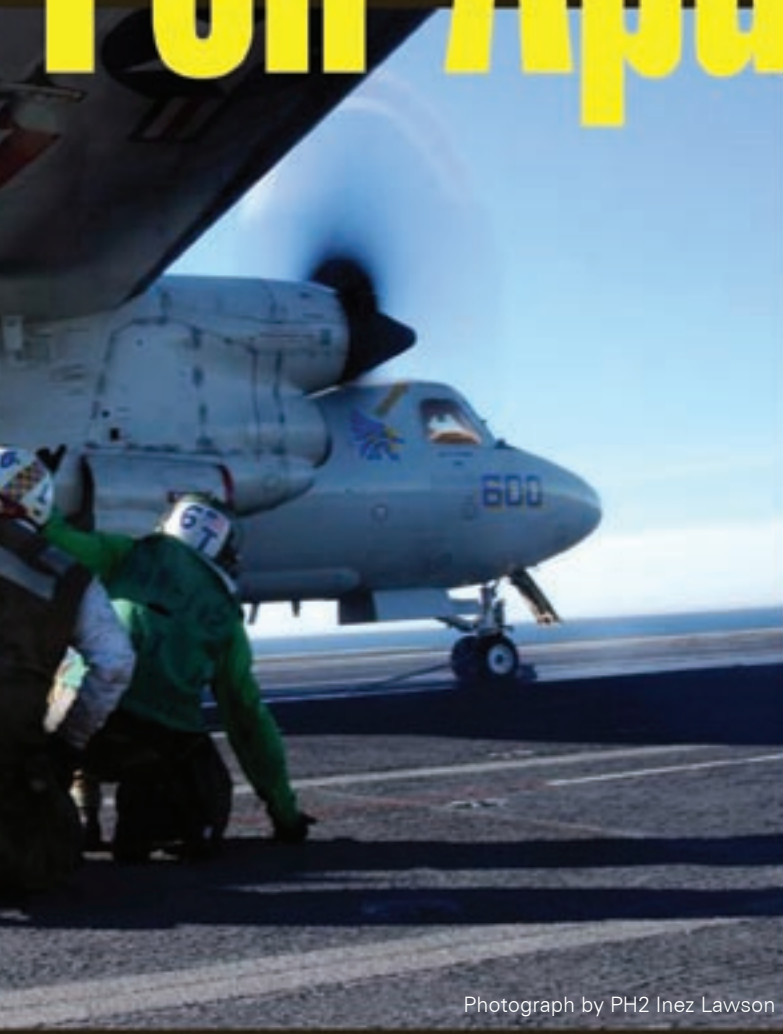
A piece of FOD this size can cause big problems.
